Nikola Miletić, University of Belgrade, nikola.miletic@arh.bg.ac.rs  
Dušan Ignjatović, University of Belgrade, ignjatovic.dusan@arh.bg.ac.rs  
Bojana Zevković, University of Belgrade, bojana@arh.bg.ac.rs  
Nataša Ćuković Ignjatović, University of Belgrade, natasa@arh.bg.ac.rs

## ENERGY EFFICIENT REFURBISHMENT OF MUNICIPAL PUBLIC BUILDINGS IN BELGRADE, SERBIA

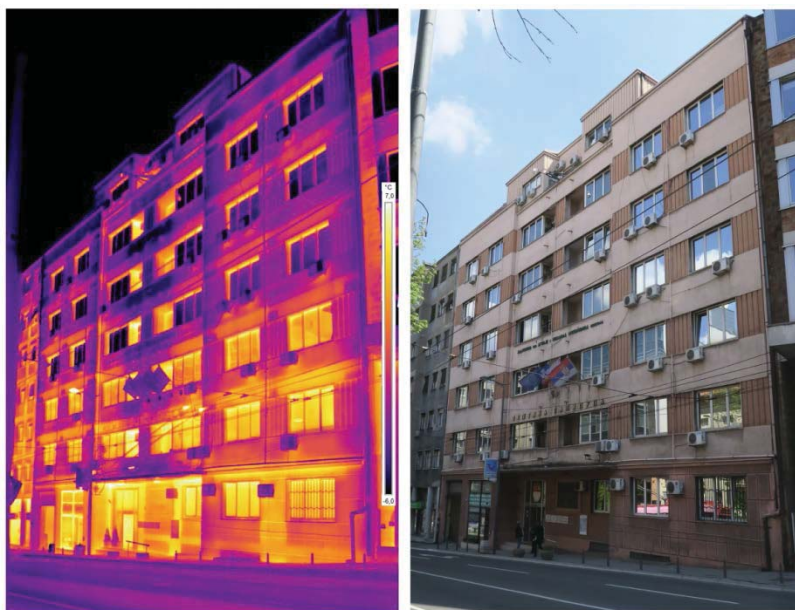
Figure 1. Thermal imaging and photograph of the street facade of the building of the City Municipality of Palilula. The image clearly shows heat losses in horizontal reinforced concrete cerclages as well as beams over windows. No vertical reinforced concrete elements are observed

- Replacing existing PVC windows with new ones, with six-chamber PVC profiles with triple glazing filled with argon and low-emission coating. The geometrical characteristics of the newly planned windows (size and composition/division) are the same as existing ones, but the newly planned windows are characterized by a better heat transfer coefficient of  $U = 1.5 \text{ W/m}^2\text{K}$ .

- Thermal insulation of the courtyard facade was performed by placing a thermal insulation layer of 12 cm of stone wool over the existing facade.
- Thermal insulation of the courtyard facade overhangs was performed by placing a layer of stone wool 15 cm thick and a final layer of cement mortar.
- Thermal insulation of mezzanine structures towards the attic space was performed by installing a layer of 15 cm stone wool with the addition of appropriate protective layers (steam dams, protective foils) in accordance with the requirements of building physics.
- The thermal insulation on the part of flat roof was planned. A 20 cm layer of stone wool on the underside and finished with plasterboard on the appropriate substructure.

- Thermal insulation of the street facade was performed by installing a thermal insulation layer of 12 cm of stone wool. The street façade is characterized by relatively reduced façade plastic,

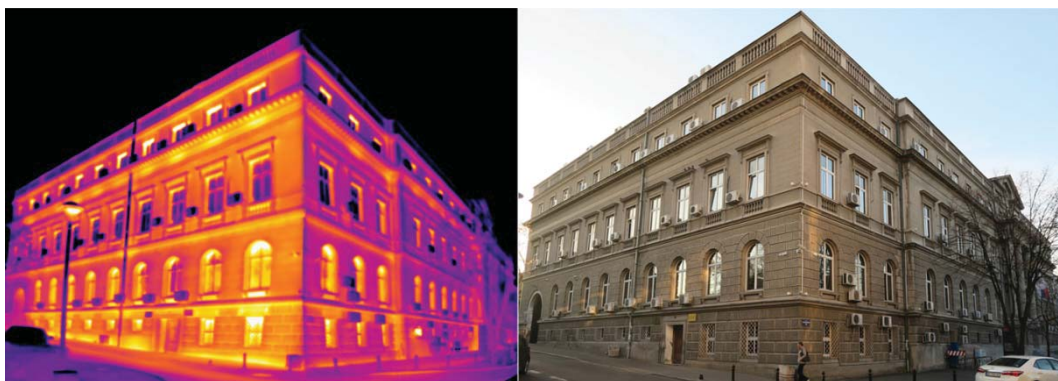
The available project documentation cannot determine the existence of reinforced concrete elements, as well as thermal imaging conducted during the energy audit, except in the extended part of the building. (see Figure 3)

Figure 3. Thermal imaging and photograph of the street facade of the building of the City Municipality of Zemun. Heat losses are evident in the area where concrete beams are - over windows and in the area of window openings

- Replacing existing PVC windows with new wooden ones, according to the conditions obtained from the Institute for the Protection of Cultural Monuments of the City of Belgrade. The newly planned solid wood windows are glazed with thermopane glass with geometric characteristics (sash division and decorative moldings) matching the original windows, according to the available information on the original windows. Newly planned windows are characterized by a heat transfer coefficient of  $1.5\text{W/m}^2\text{K}$ , in accordance with the Rulebook [5]. The dismantling of the existing as well as the installation of new windows is planned on the inside of the building, so as to reduce the risk of damage to the facade, that would require additional work.

- Thermal insulation of the courtyard facade by placing a 10 cm thick stone wool layer over the existing facade.
- Thermal insulation of the courtyard facade overhangs by placing a layer of stone wool 20 cm thick and a final layer of cement mortar on the rabbit net.
- Thermal insulation of slabs towards the attic space was done by installing a layer of 20 cm stone wool with appropriate protective layers (steam dams, protective foils) in accordance with the requirements of building physics.
- Thermal insulation of pitched roof above the attic office space was performed by adding a thermal insulation layer of 24 cm of stone wool between the existing rafters.

- Insulating the street facade was by installing a thermal insulation layer of 10 cm of stone wool on the inside of the facade wall, due to the limitations issued by the Institute for the Protection of Cultural Monuments of the City of Belgrade.
